# Buildings left standing in Turkey offer design guidance for future earthquake-resilient construction

By [Osman Ozbulut](#)

5 Apr 2023

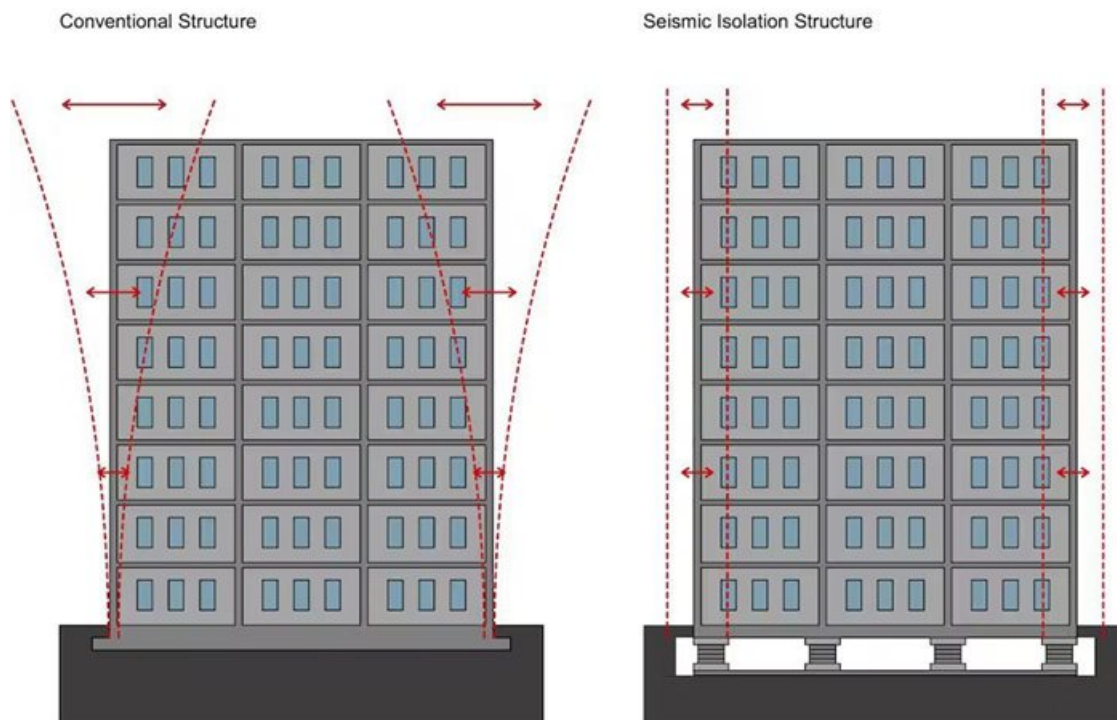
The left shows a building without seismic isolation, while the right image shows a building with a seismic isolation system which minimises how much damage the building sustains during an earthquake. The red lines denote how much motion the building could experience during an earthquake. Ozbulut Lab, CC BY-ND

[Seismic isolation systems](#) prevent seismic energy from entering buildings in the first place by using devices made from rubber or steel plates coated with a friction-generating material that slide over one another to minimise an earthquake's impact. These isolation devices are installed between the building's foundation and the building itself. Alternatively, seismic dampers, installed in each story of a building, absorb earthquake energy the way shock absorbers work in a car and convert it into heat energy to [minimise damage](#).
