# M&C Zambia completes compressor motor overhaul in rapid time

In August 2022, Marthinusen & Coutts Zambia was tasked with a challenging assignment. A smelter based in the Copperbelt region requested an in-country repair solution for their two critical 4.5MW compressor motors. The company was given a tight deadline of just three weeks to overhaul and commission the motors.

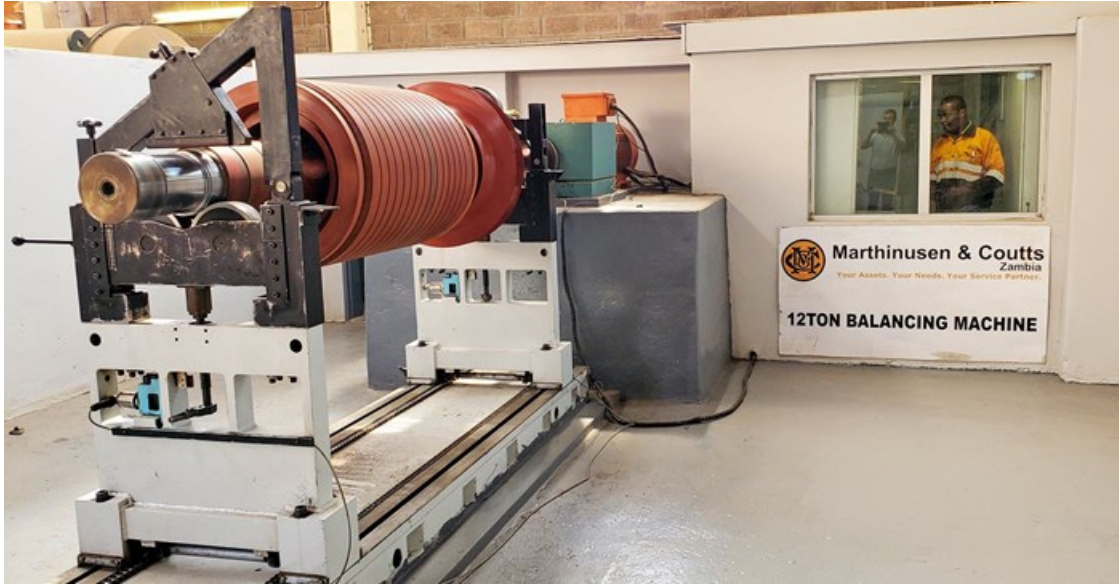
The comprehensive scope of work involved dismantling, cleaning, and assessing all parts of the motors. The team at then dynamically balanced the rotors at operating speed using their own 12-tonne balancing machine.

Following this, they supplied new bearing assembly parts and assembled the motors. The final steps included a no-load test and laser alignment of the motors on site. This rapid and efficient response showcases the company's commitment to providing high-quality, timely solutions to its clients.

“Upon dismantling both motors we identified that the stator coils indicated partial discharge and the stator wedges had deteriorated significantly over time. We consequently requested M&C’s workshop in Cleveland, Johannesburg to supply partial discharge treatment of the stator coils and to manufacture the stator wedges that needed to be replaced,” said Eugene Lottering, M&C Zambia’s GM.

“Our team is well experienced in how to approach and action various stages throughout the overhaul of these motors. We successfully completed various medium voltage overhauls up to 4,650kW. The motors were no-load tested at 11kV with exceptionally good results and the customer then gave us the go-ahead to commission the motors,” Eugene explained.

The motors were finally tested on load, recording satisfactory vibration levels of below 1.34mm/s.
